Manhole Inspection Summary

Manhole # S13C__016MH

Location Address: **500 POPLAR GROVE ST**

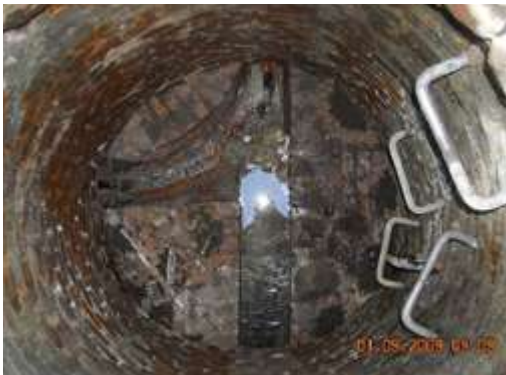
Defect 2

☒ **Evidence Of Surcharge** Depth: **2** (ft.) ☐ Active Surcharge Present

evidence surcharge

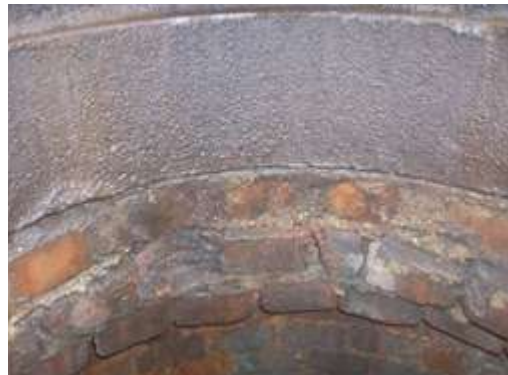
Defect 1

Condition: ☐ Sound ☐ Cracked ☐ Root Intrusion ☒ **Loose Brick** ☐ Deteriorated

LOOSE BRICKS ON CHIMNEY
